CITY OF BALTIMORE SMOKE TESTING OBSERVATION SUMMARY LOW LEVEL SEWERSHED

BALTIMORE CITY PROJECT 1029 REI/DRAYCO

Unique Test ID: 567	Date:	08/27/2008	Basin: LL - 44	Manhole ID: S19K048MH
Defect No: OB01	Supervisor: E.R.	Crew: 04		Dye Test Recommended: N

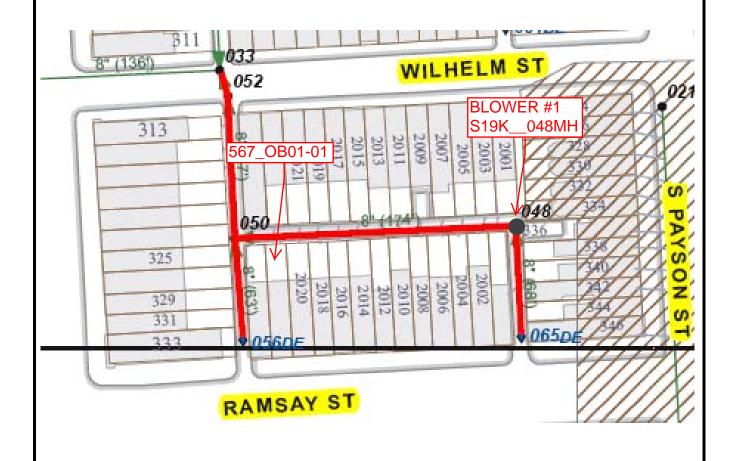
Field Sketch: (Show all manholes with numbers, blower placement location, sandbag or isolation locations, street names, building addresses and locations, defect locations and photograph numbers)

CITY OF BALTIMORE WET WEATHER CONSENT DECREE SMOKE AND DYED WATER TESTING FORM				Page 2 of 3							
,	Sewershed: Low Level Subsewershed: 44	Company: REI/DRAYCO					СО	Date: 08/27/2008			
	Test Type: Smoke	Ground Condition: Dry: X Damp:_ Wet:_					:_	Supervisor: E.R. Crew: 04			
	nhole ID: S19K048MH					29-567			Re	esider	tions Made:X nts, Fire, 311
Field SI	ketch: (Show all manholes with nun		blower pla ations, de							ons, s	treet names, building addresses
Defect No.		110 100	Source Type			Sector	Drai	nage rea			Photo Number
1	2022 RAMSAY ST.		03	0	8	02		0	03		1029-567_OB01-01.jpg

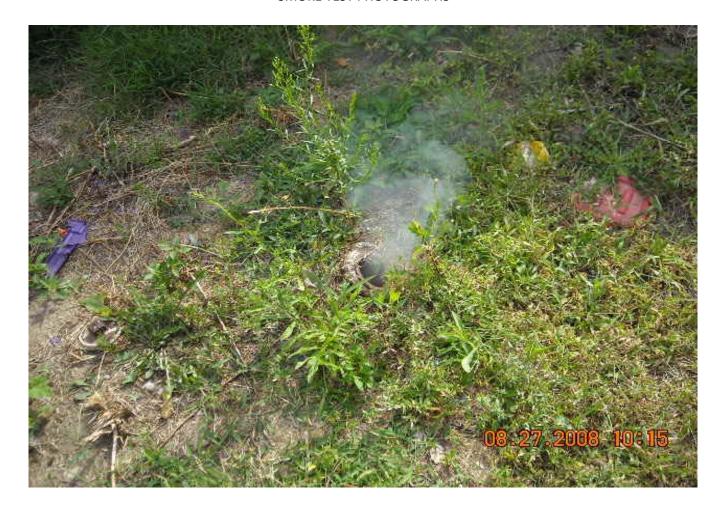
Photograph No: OB01-01 Filename: 1029-567_OB01-01.jpg

Location: 2022 RAMSAY ST.

Source Type: 03 Cleanout Sector: 02 Private

Location: 08 Yard - Back Severity: 03 Moderate Drainage Area: 0

Comments: ABOVE GRADE CLEANOUT IN BACKYARD WITHOUT CAP.
